Navajo Abandoned Uranium Mine Site Screen Report

Section 4 AUM Site

Navajo AUM Eastern Region

Weston Solutions, Inc.

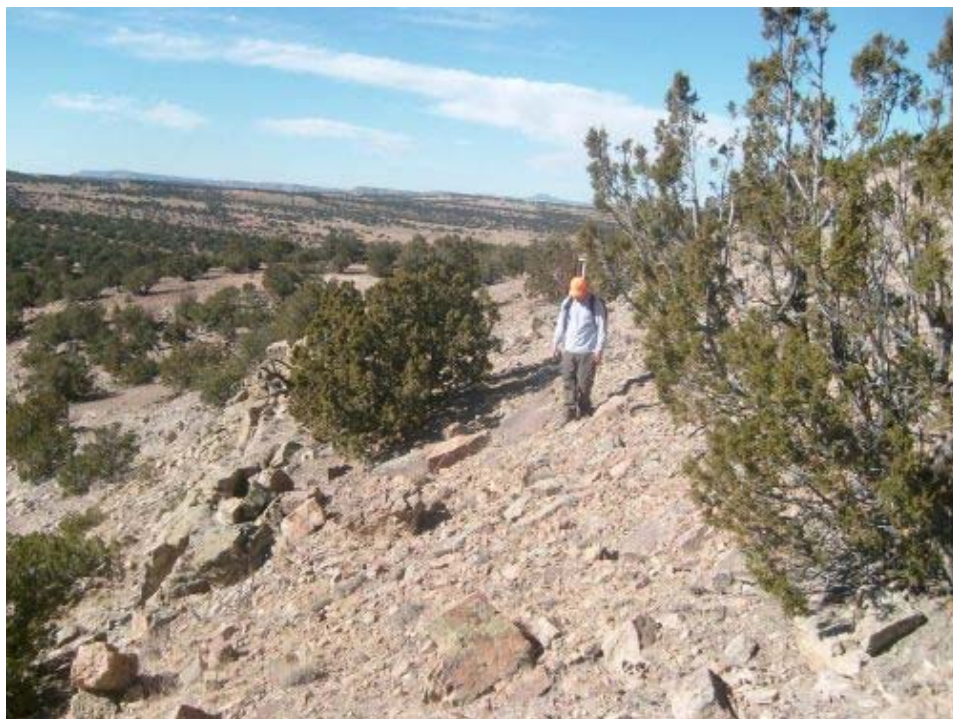
Reclamation status of the mine site is currently unknown. No waste piles, adits, pits, or other features were observed during the site visit.

Photo 1. Section 4 mine site, towards the north

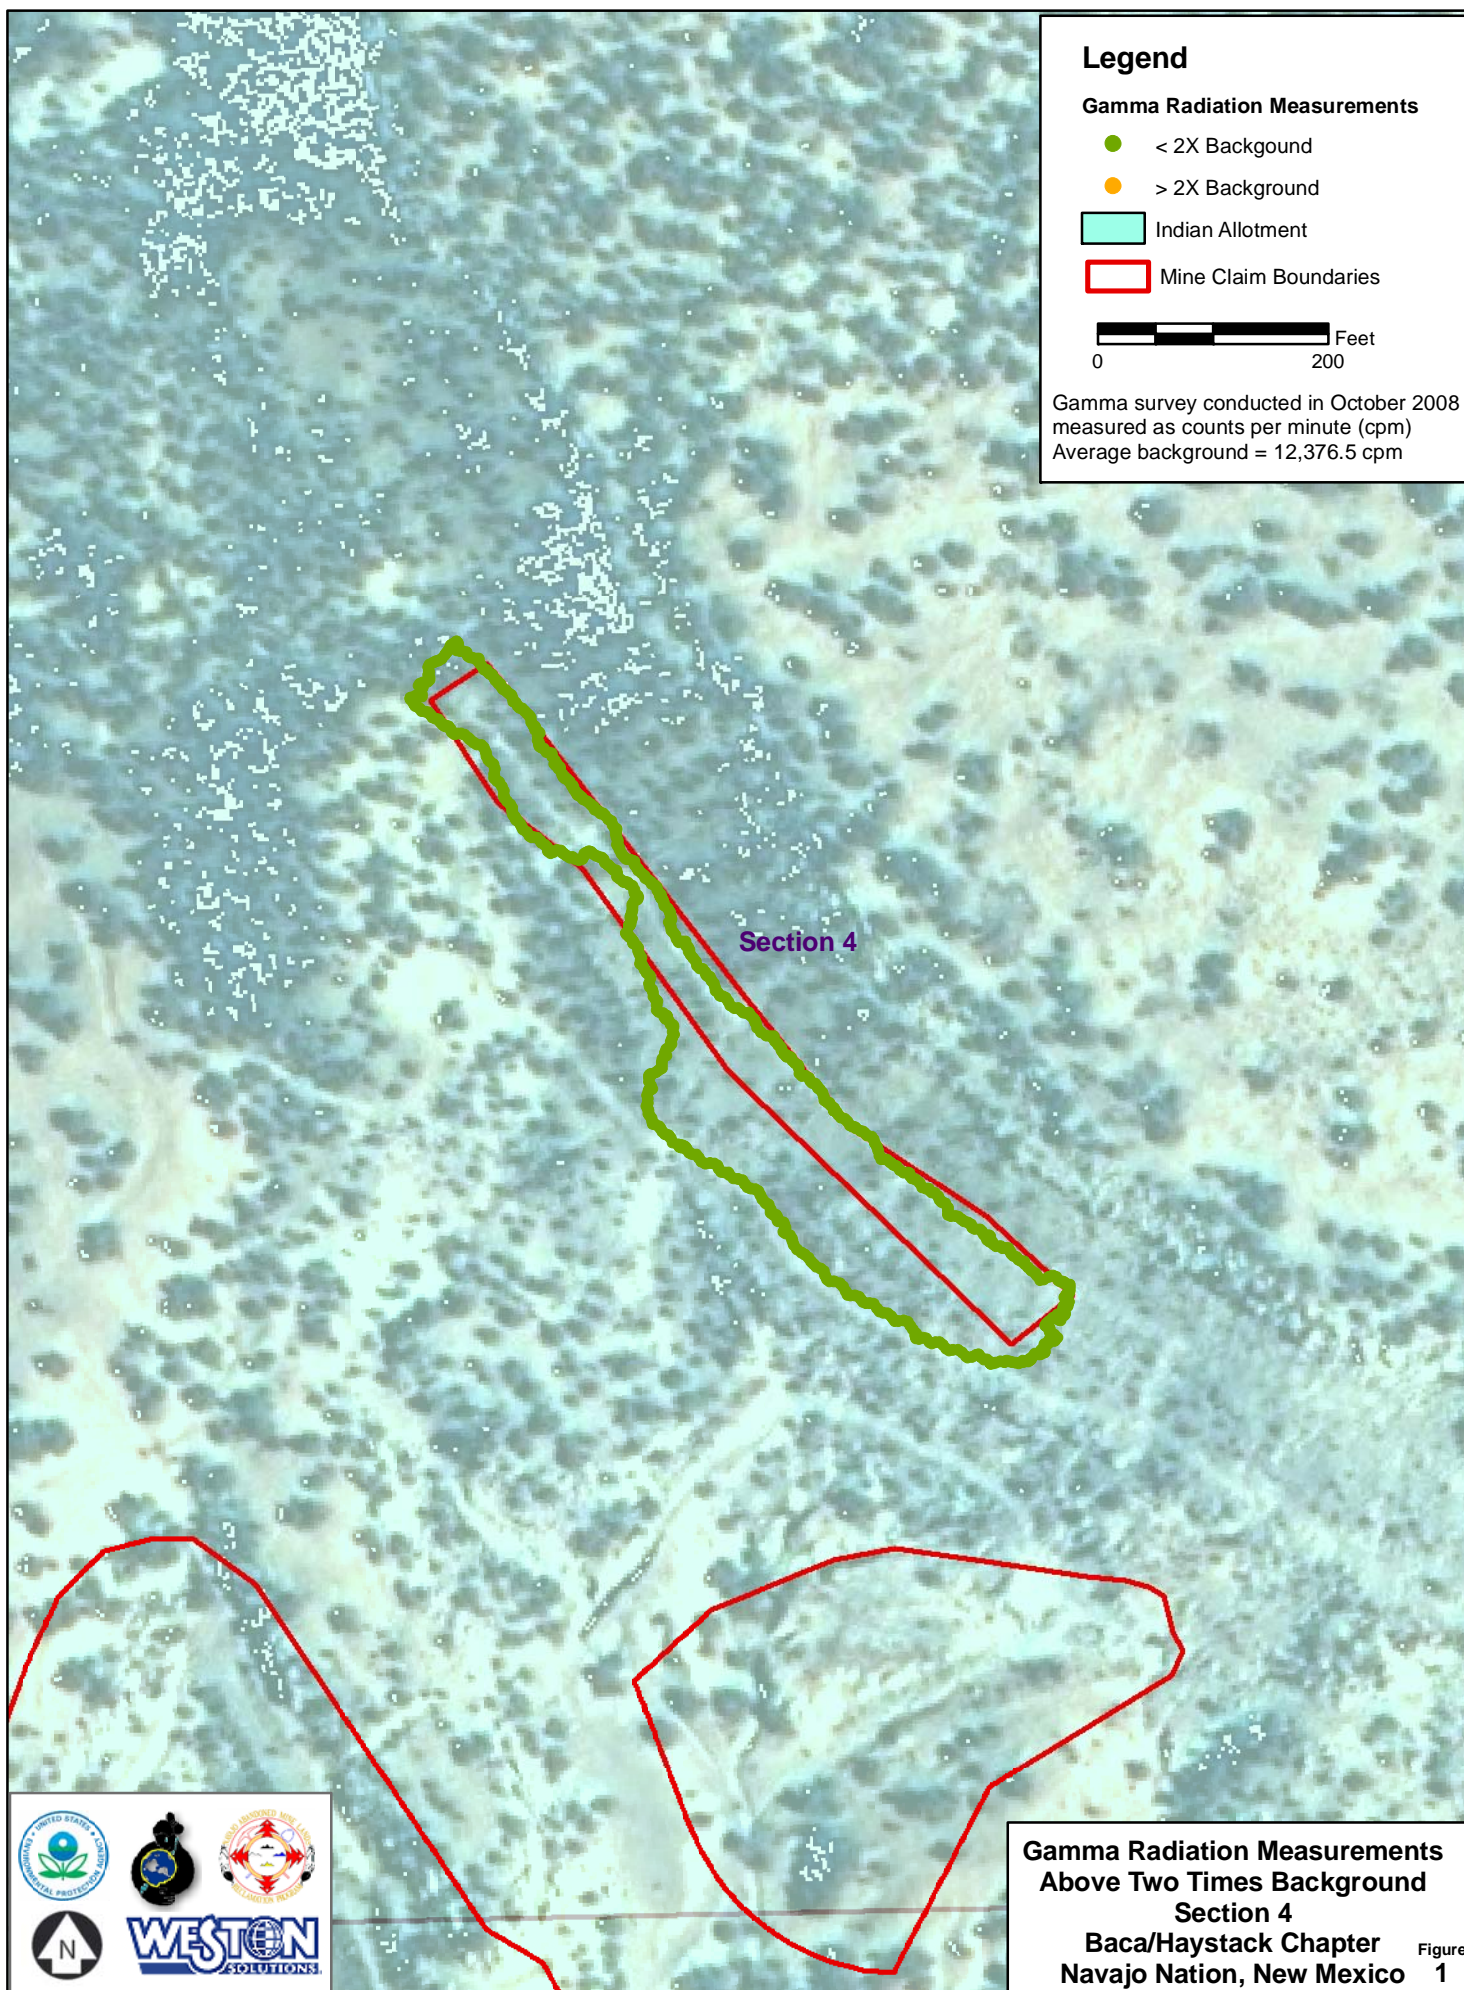
A total of 912 gamma radiation measurements were collected from the mine site, ranging from 9,207 cpm to 20,788 cpm. The measurements are represented in Figures 1 and 2.
